# Repair of a Highly Displaced Comminuted Femoral Neck Fracture in a Young Patient

Treatment of femoral neck fractures often come with complications. This case demonstrates the successful repair of a 21-year-old male with a highly displaced, comminuted femoral neck fracture sustained in a motor vehicle collision. Utilizing the Femoral Neck System (FNS), the fracture healed and the patient was able to return to a productive, active life.

**AO 31B2.2**

**Garden IV / Pauwels III**

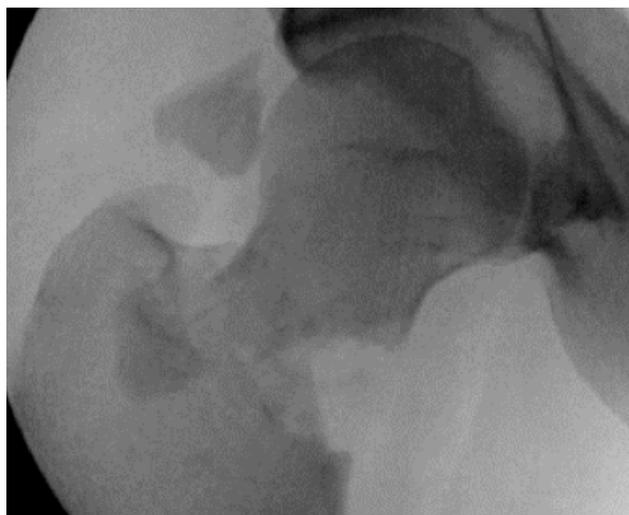
A 21-year-old restrained male driver was involved in a head-on motor vehicle crash sustaining facial, thoracic spine, distal humerus, olecranon, radius, open femoral shaft, tibial plateau, fifth metacarpal, and a highly displaced right femoral neck fracture (Garden IV, Pauwels III, AO 31B2.2) (Figure 1).

Radiographically, the femoral neck fracture was multi-fragmented with a vertical shear pattern. A large fragment from the inferior femoral neck, which is essential for transmitting load from the femoral head to the femoral shaft, was completely displaced and sitting in the soft tissues superior to the femoral neck.

**Figure 1: Initial pre-operative radiograph of right femoral neck**

The patient was young and active therefore the decision was to repair the femoral neck. Given the complex fracture pattern and level of displacement, an anatomic reduction was expected to be difficult to achieve, and maintaining it during implant insertion was going to be challenging.

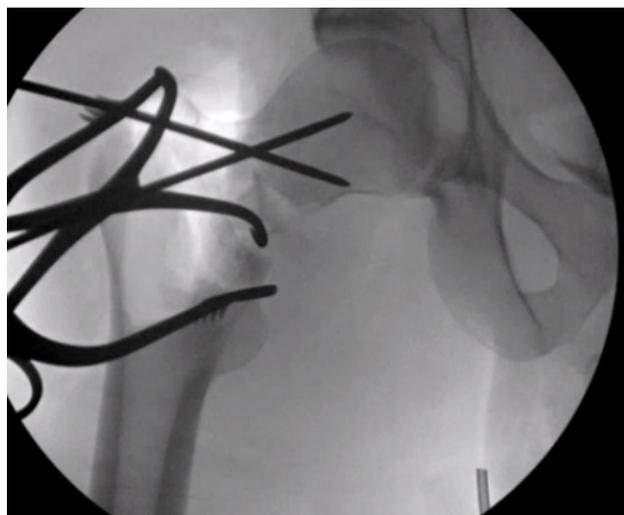
**Figure 2: Intra-operative radiograph of right femoral neck following reduction**

The patient's leg was hung off the end of the table to provide traction. A Hueter Approach (modified Smith-Peterson Approach) was used to provide direct anterior exposure to the femoral neck to attempt an open reduction.

The patient had a sizable bone fragment from the inferior femoral neck that was essential to reduce so that the load placed on the implant would be shared with the fragments of the femur during healing, otherwise the implant may fail. Weber Clamps and 4mm Schanz Pins, acting as "joy sticks", were used as reduction aids and while irregularities of the inferior calcar complicated a pure anatomic reduction, the use of an open approach provided the opportunity to reduce the fracture as close to anatomic as possible (Figure 2).

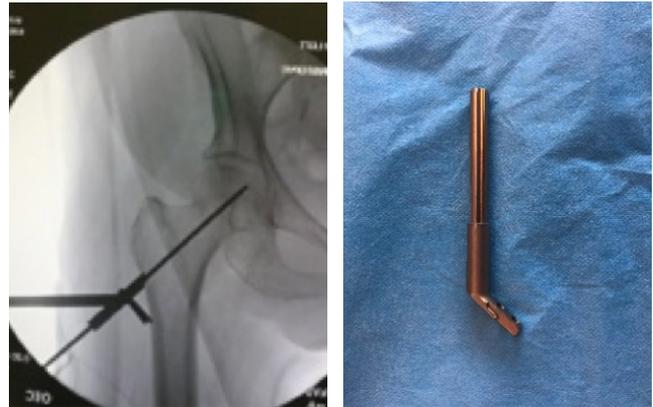
**Figure 4: Intra-operative radiograph of guide wire placement in the femoral head and back-table image of smooth bolt**

**Note:** This radiograph is taken from another case and used for illustrative purposes.

After inserting a single guide wire into the femoral head, a measurement was taken, and the implant size was determined. As the bolt is smooth, reduction was able to be maintained without mal-rotating the femoral head during insertion (Figure 4).

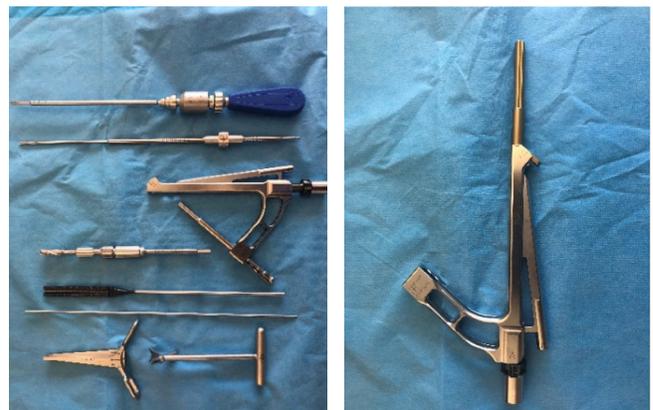
**Figure 5: Intra-operative insertion of antirotation screw, back table instruments, and assembled bolt on targeting jig**

The antirotation screw is inserted through the bolt to create one fixed assembly. Once the antirotation screw is inserted, the plate position is set. The position of the plate was checked using the image intensifier to ensure center placement in relation to the shaft of the femur prior to drilling and inserting the antirotation screw. All components of the FNS implant were inserted with a few instruments through a targeting jig (Figure 5).

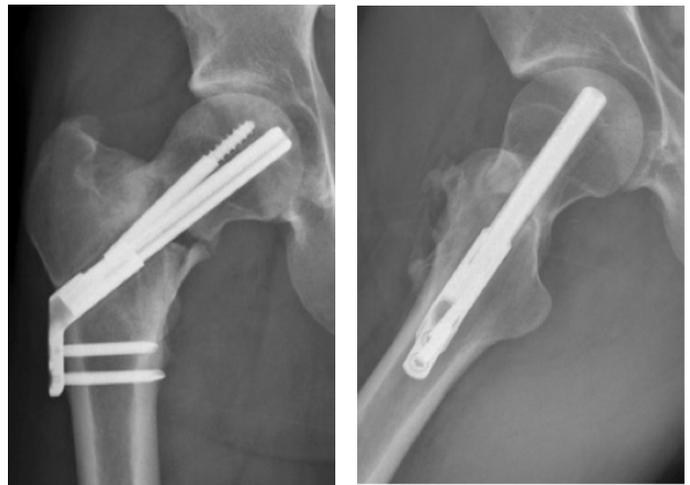
While the patient was lost to immediate follow-up, he returned six months and one year later for evaluation. His femoral neck fracture had healed, the FNS implant was intact, and the patient was ambulating pain free without a limp (Figure 7). The patient went on to heal all his injuries without additional operations and could once again ride his bicycle, jog, and work as an autobody mechanic.

The only unknown at this time was whether the femoral head would develop osteonecrosis, which may take up to two years to become evident.<sup>4</sup> This is true for all femoral neck fractures however early results for this patient are promising.

**Figure 7: Radiographs from six month follow-up of patient**
