Valgus Impacted Non-displaced Subcapital Femoral Neck Fracture in Elderly Patient

Tomohiro Matsumura, MD

Jichi Medical University, Tochigi, Japan

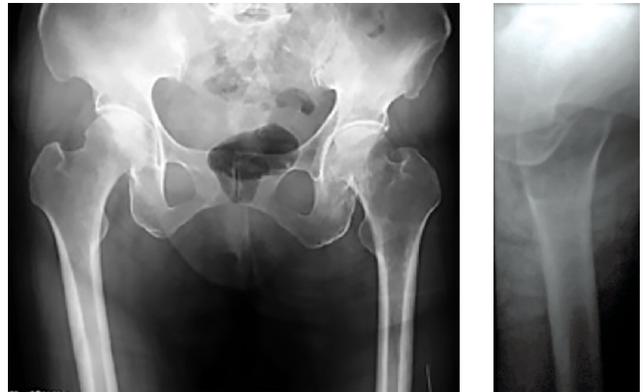
Figure 1: Pre-operative radiographs of left femoral neck

An 84-year-old female Japanese patient presented with left sided hip pain after falling while walking. Initial x-rays indicated a non-displaced subcapital femoral neck fracture, with possible valgus impaction of the femoral neck (Figure 1). A Pauwels Type II or AO/OTA fracture and dislocation classification 31B1.1 was confirmed with 2D Computed Tomography (CT) imaging (Figure 2).

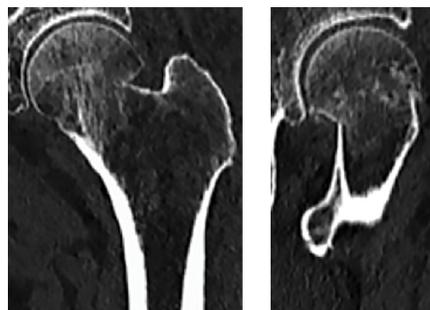
Figure 2: Pre-operative 2D CT images (coronal and sagittal)

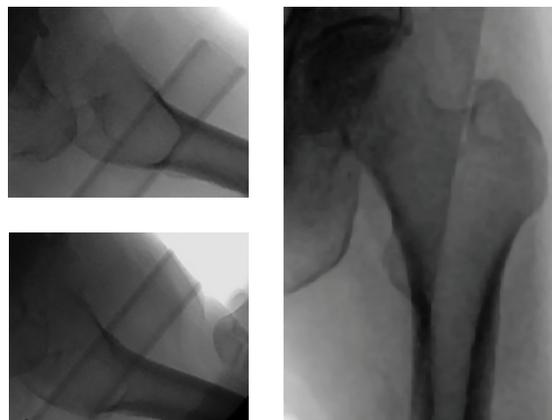
Figure 3: Intra-operative radiographs of fracture reduction with traction

The following day the patient underwent surgery to stabilize the subcapital femoral neck fracture with the FNS implant. Intraoperatively a traction table was used to position the patient and the fracture was reduced manually through traction and internal rotation to regain leg length. Alignment was checked in both the AP and Lateral views (Figure 3). While the surgical technique recommends the insertion of a femoral neck guide wire to prevent any inadvertent rotation of the femoral head, the fracture reduction appeared stable and was observed throughout to remain stable.

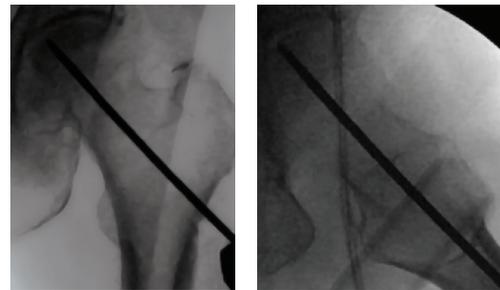
Figure 4: Intra-operative radiographs of the measuring guide wire placement

A guide wire was placed centrally in the femoral neck, using a 130° angled guide, to provide implant measurement (Figure 4). The guide wire measurement device indicated a length of 92 mm from the center of the femoral head. Technique recommends rounding down (i.e. 90 mm) and remove 5 mm (i.e. 85 mm) from the value seen on the measuring device to determine the appropriate implant size, therefore an 85 mm FNS implant was used.

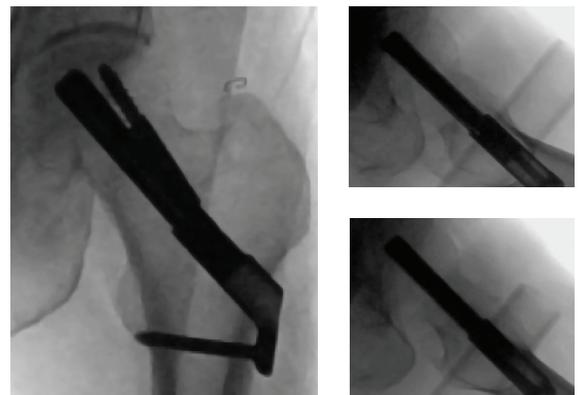
Figure 5: Intra-operative radiographs post fixation

The bolt is inserted over the central guide wire into a pre-reamed hole. Special consideration was taken to ensure the plate was positioned along the femoral shaft, and the guide wire was subsequently removed. The antirotation-screw was inserted next, followed by the locking screw (Figure 5). If required, intraoperative compression of fragments can be applied with the use of the multifunction rod – acting as a compression instrument – which should be done after the antirotation-screw and locking screw are inserted.

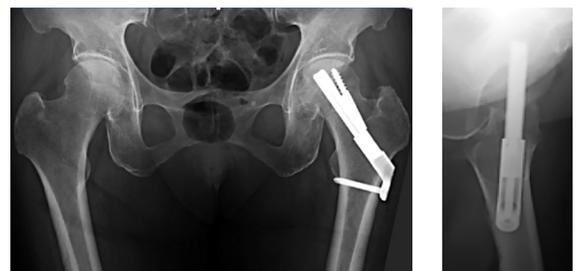
Figure 6: Immediate post-operative radiographs

The day after surgery the patient was able to fully weight bear during walking and had no perioperative complications at discharge (Figure 6). At the 3-month follow up the patient had no reported complications; her Harris Hip score was 84 and walking ability was restored to the same level as before the fracture.

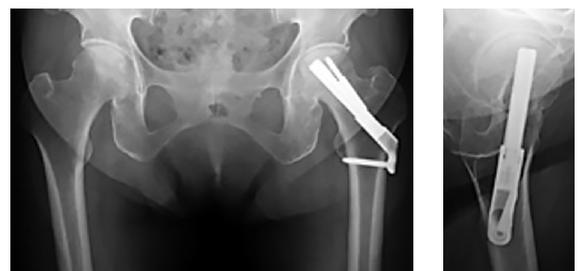
Figure 7: 3-month post-operative radiographs

The patient was allowed to weight bear as tolerated after surgery. Her post-operative course was uncomplicated. She was seen at 2-week, 6-week, and 3-month intervals and was noted to be pain-free and doing well. At 3 months she had completely recovered from her injury (Figure 7).
